TECHNICAL MEMORANDUM

City of Alexandria Storm Sewer Capacity Analysis

Task Order 2D – Heavy Cleaning & CCTV (N. Beauregard St)

Storm Pipe Segment: 001316STMP

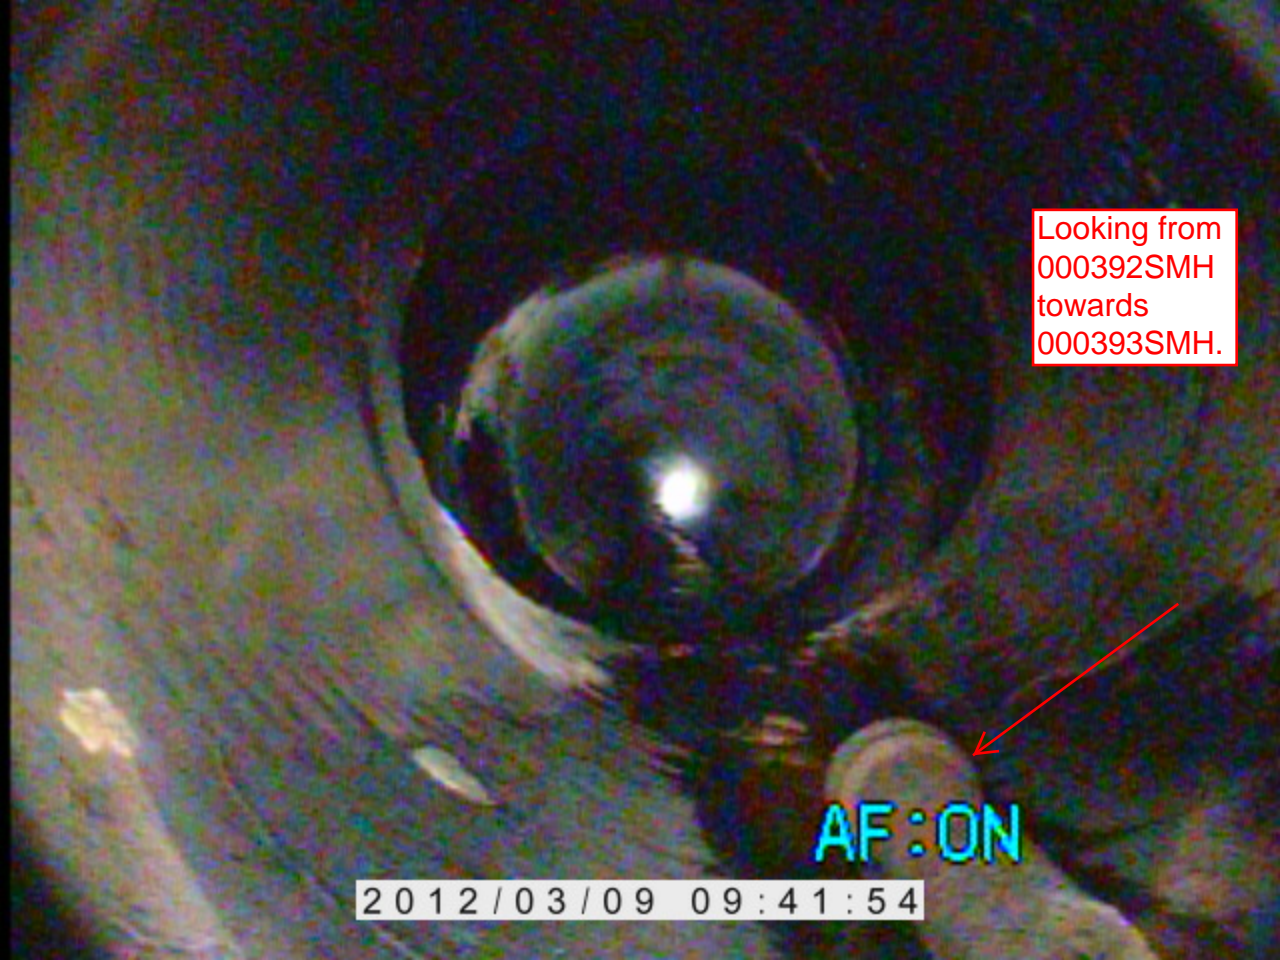
0119.9' 07/06/12

At the downstream end of the subject line (just beyond manhole 000392SMH) there is a 6-inch diameter pipe apparatus, believed to be abandoned, affixed to the bottom of the storm pipe. The original function of the 6-inch pipe is not known. The included images (Appendix D) display the location and orientation of the pipe. VPS reported that the pipe is fused to the bottom of the storm sewer pipe with cement mortar and was unable to separate the two pipes for removal. Regular maintenance and cleaning is essential to eliminate the potential of debris accumulation at this location.

IMAGES OF 6-INCH PIPE APPARATUS INSIDE 57-INCH STORM MAIN
